Safety Alert

Stop use Petzl ZIGZAG mechanical Prusik

Sku. D22

This information is complementary to the Safety Information issued April 15, 2013

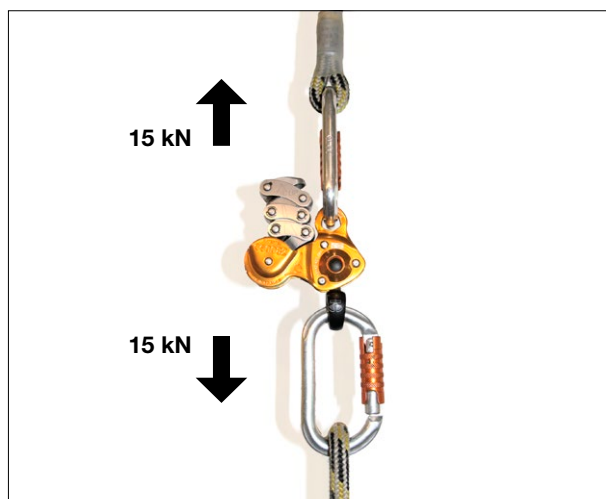
1/3 - Breaking strength of the ZIGZAG's rope end attachment hole

With this carabiner configuration, the breaking strength of the rope end attachment hole is greater than 15 kN.

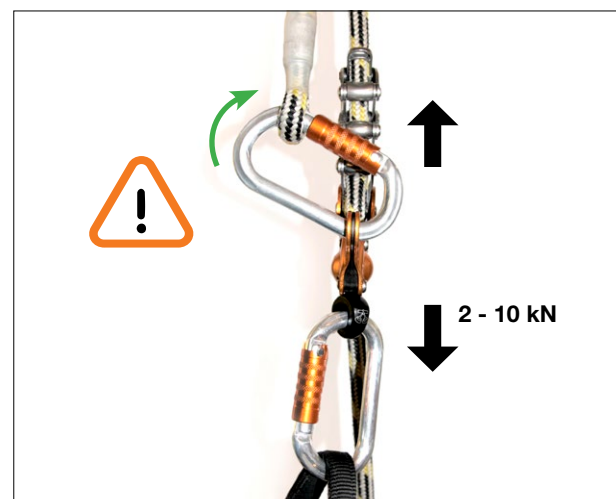
2/3 - ZIGZAG with a cantilevered upper carabiner

This is an incorrect configuration.

Note: most of the carabiners tested this way pivot and correct themselves to be loaded on the major axis starting at 2 kN of force. Some carabiners pivoted and corrected themselves at 10 kN, without damaging the upper attachment hole.
