**ART** calls on all BlackBird owners to replace the **upper bearing pin of the friction enhancer** along with the corresponding screw.

### **“Nose” – Right Side Plate of the Friction Enhancer**

**BlackBird**

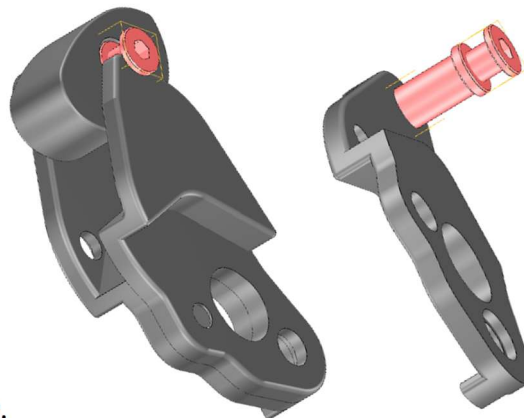
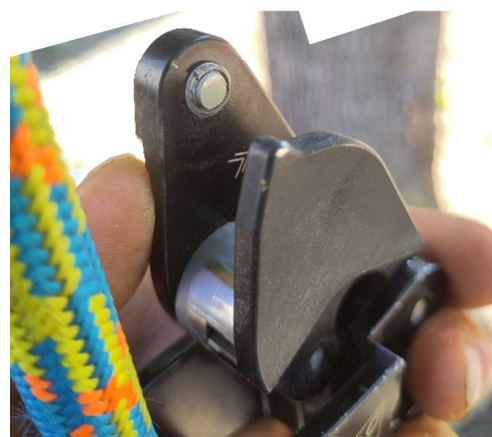
During inspections, we have identified isolated cases of variations in the material strength of the upper bearing pin. These variations could lead to a pin fracture and, consequently, failure of the upper clamping jaw. There is no immediate risk of a fall, as the remaining clamping jaw inside the BlackBird's body maintains reliable clamping even if the upper bearing pin were to break.

The required replacement kit (including instructions) will be provided free of charge and will be available from calendar week 45. The new pin features a significantly increased wall thickness, and the corresponding screw engages much deeper into the pin; the thread is now positioned in the rear section of the pin to provide greater overall strength.

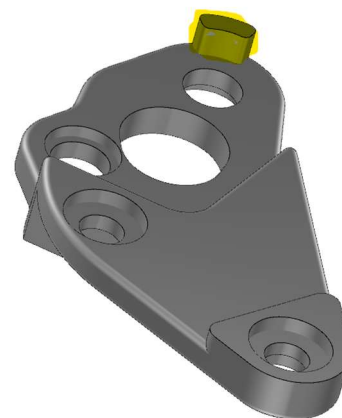
A few climbers have also informed us that the “nose” on the friction enhancer has broken off. The nose stop is designed to regulate the clamping movement of the friction enhancer.

If the nose breaks, the friction enhancer can extend fully, causing the entire system to lock up. There is no risk of a fall in this situation.

We have already reinforced this area with two stainless-steel pins, but this measure alone is not sufficient to completely prevent the shearing of the nose.

To address this issue as well, we have decided to manufacture the right side plate of the friction enhancer, and thus the “nose,” from stainless steel. This significantly increases the material strength and greatly enhances the overall robustness of the BlackBird. At the same time, we have optimized the contours to limit the weight increase to only 40 grams.

You may choose whether to have the side plate replaced as a precautionary measure or only in the event of a damaged “nose.” The replacement is **free of charge** and must be carried out at ART’s facility. We expect to be able to perform the full replacements starting in calendar week 49 and will begin accepting your returns from week 48.

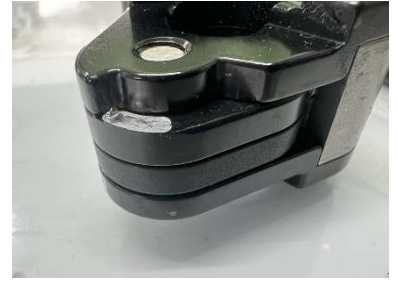
The BlackBird is certified by **TÜV Süd** in accordance with **EN 12841** and has successfully passed numerous tensile tests without any issues. The breakage of the “nose” described here occurred exclusively during use in SRT (Single Rope Technique) and in combination with a resin-contaminated rope.

When used with such a rope, the friction enhancer may temporarily seize. If the release lever is then fully actuated, the enhancer can suddenly extend, transferring a sharp impact force directly onto the small “nose”, which may shear off as a result.
