Information for the users of the Petzl ZIGZAG

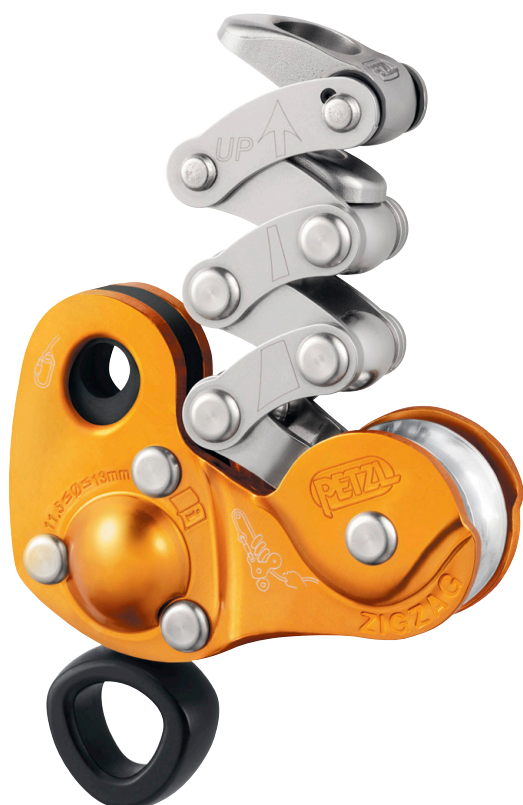
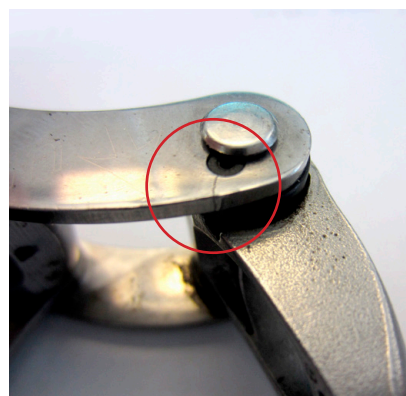
Two different customers have informed us of the presence of a crack on one of the ZIGZAG's steel chain links. Both units have been returned to petzl for analysis.

A cracked link presents no additional risk to the user. However, the presence of such a crack requires immediate retirement of the ZIGZAG.

- Regularly inspect your ZIGZAG in accordance with the ZIGZAG PPE checking procedure.
- In the unlikely event you find a cracked link, retire your ZIGZAG immediately and contact your local Petzl distributor for a replacement under warranty.
- A cracked link presents no additional risk to the user. However, like for any PPE , the presence of such a crack requires immediate retirement of the ZIGZAG.
- These recommendations therefore apply also to the Petzl ZILLON.

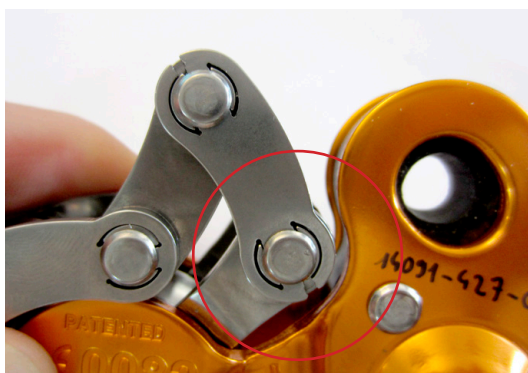
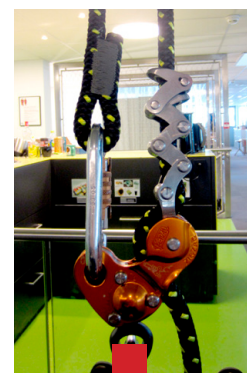
14 kN

we intentionally cut one of the steel links in the ZIGZAG friction chain and performed tensile tests. We cut the link located at the bottom of the chain, as those links are subject to the greatest force.

- The cut link failed at 14 kN, resulting in deformation of the opposite link. However, the chain always remained connected to the body of the ZIGZAG. The same test on an upper link intentionally cut (same damage than one of the two returned cracked ZIGZAG) leads to the same result.

- In a dynamic suspension, the cut link is deformed but not broken (see photos below).
